## **National Register of Historic Places Registration Form**

Dodger Point Fire Lookout

Summary: The Dodger Point Fire Lookout is a square, 1-story, wood building with a wood-shaked gable roof set on a dry-laid rock foundation. The lookout is located on the peak of Dodger Point in an alpine meadow above timberline. The location provides a 360-degree view of Olympic National Park. The lookout is in good condition and there are no known alterations that have occurred to it since constructed by the United States Forest Service in 1933, possibly with Civilian Conservation Corps assistance. The building has integrity of location, setting, design, materials, workmanship, feeling, and association.

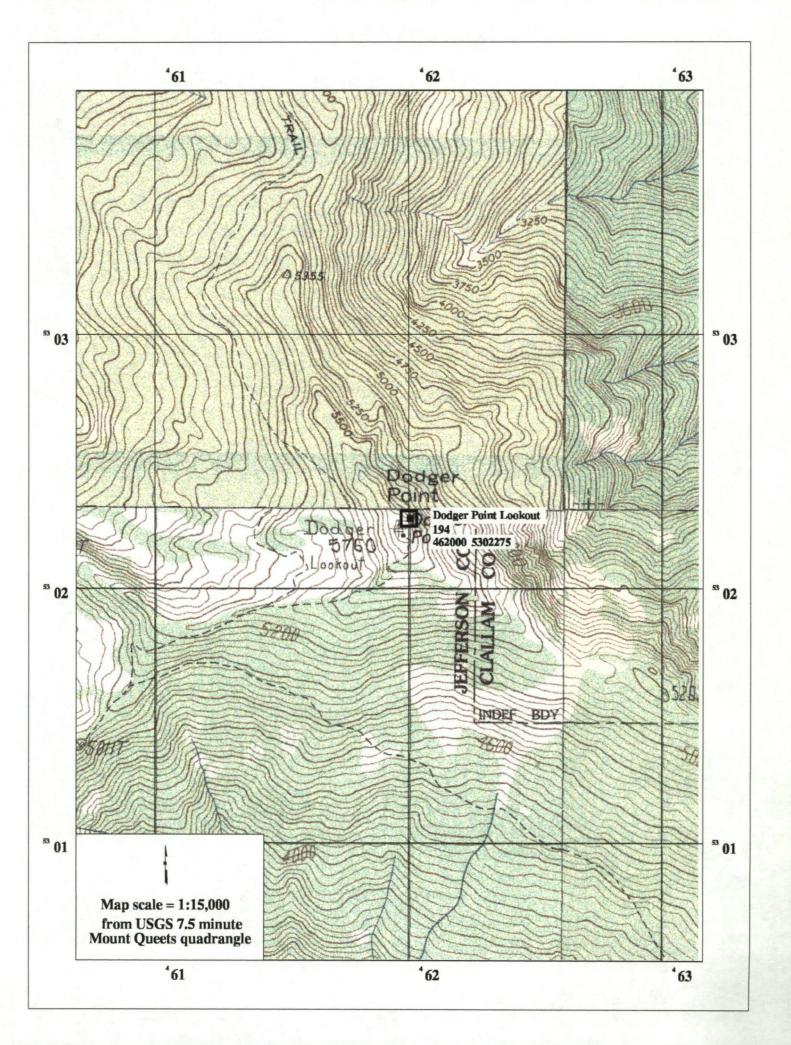
Square in shape; measures approx. 15' x 15'; 1 story; wood-frame wall construction, with horizontal clapboard siding; gable roof with shake roofing (no eaves); stone foundation; 5 windows on each elevation (except on N.W. elevation where door takes up 1 bay); windows begin 3 1/2' from foundation up to beginning of gable; they are multi-light; door, multi-light in upper portion, lower portion paneled. Alterations: none apparent. Siting: on peak of Dodger Point with 180 degree view, above timber line, alpine meadow. Other: substantial shutters in deteriorating condition have been placed over all windows. Therefore, every elevation has these "shutters" of horizontal boards with battens and cross brace, secured by heavy bolts and hinged at the top; the interior has wooden floor; interior wall paneling is
